Automated Process Metrology in Solar Cell Manufacturing

Abstract — Optimizing a solar cell manufacturing line must take into account a variety of issues. Wafers used for solar cells are typically thinner than those used in semiconductor IC manufacturing. This makes the solar cell wafers susceptible to surface and edge defects such as deep scratches and cracks. The wafer slicing operation can induce thickness non-uniformity as well as surface roughness variation. Wafer texturing (typically via etching) must result in an optimal pyramid height in the case of monocrystalline wafers and an optical grain size in the case of polycrystalline wafers. Silicon Nitride grown on the wafer can induce stress and eventual breakage of the wafer. An uneven nitride film can cause a drop in the overall efficiency of the wafer. The metal contact lines account for a significant cost in the production of a solar cell wafer. The process engineer must pay attention to the contact line height and width while minimizing the total amount of metal used. Based on all these requirements, an optical profiler, the Zeta-200, was developed to provide rapid and meaningful feedback to the process line. In this paper

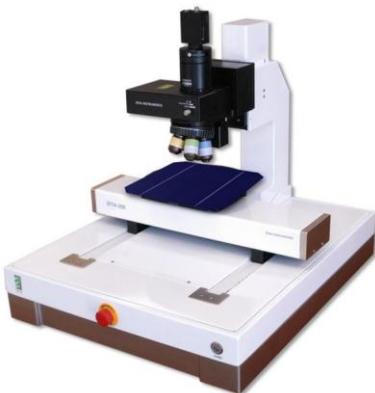
Fig. 3. The Zeta-200 optical metrology system.

A Zeta-200 (Figure 3) optical profiler was used to develop metrology solutions for each of the process steps. This non-contact 3D imaging and metrology system incorporates a ZDot™ based vertical scanning mechanism (Figure 4) as well as a wide area Interferometer and Spectroscopic Reflectometer. This flexible architecture enables a multitude of process control measurements mentioned in the previous section. In the ZDot™ mode, the Zeta-200 generates a 3D image of a surface by acquiring a stack of images at various heights, typically a few nanometers apart. Each image is then automatically analyzed to detect the pixels that are in best focus. The height and color of that pixel is recorded. Once all the pixels are accounted for, the system recreates a true color picture of the surface. Unlike a typical vertical scanning microscope, the Zeta-200 incorporates a unique optical design that enables a height resolution of 10nm (as opposed to 700nm on a typical vertical scanning microscope). Special fixtures were developed to scan the diamond wires (about 125 μ m in diameter). Roller wire-guide channel shapes were imaged by using a soft epoxy to replicate the contour of the wire guide. Another fixture was developed to hold the wafers at a tilted angle and scan the edge (side wall) of the wafer.

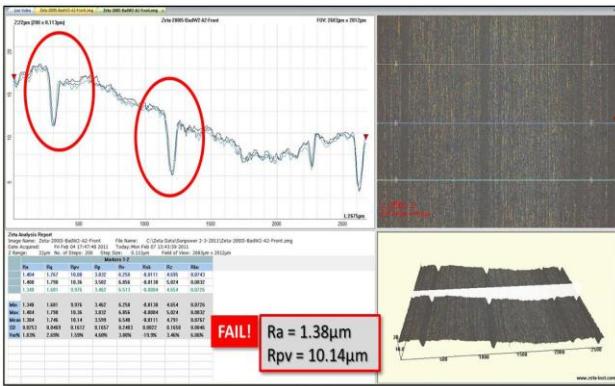
Fig. 5(b). Bad wafer quality after slicing

Monitoring incoming wafer roughness and shape is critical to ensure that the etch process will result in the desired surface structure (for example, pyramid height in the case of monocrystalline wafers). Large deviations in wafer surface topography may result in non-uniform etching and hence poor cell efficiency at the end of the line. Figure 5(a) shows a wafer with good surface roughness while Figure 5(b) shows a wafer with poor surface roughness. Note that there is a periodicity in both the surface profiles. This comes for the diamond wires oscillating within the wire-guides. However, the wafer shown in Figure 5(b) shows some deep grooves as well. Given the periodic nature of these grooves, they may be the result of unwanted vibration of the diamond wire. Therefore, it becomes important to measure both the diamond wire as well as the wire-guide from time to time.

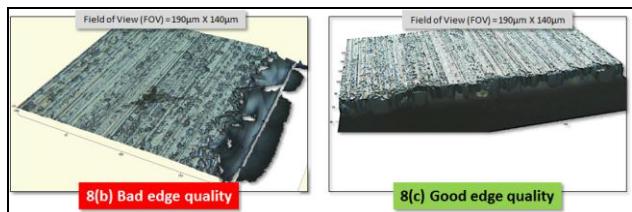
Fig. 8(b) and 8(c). Bad and good wafer edge.

The edge grinding process is critical to creating a clean wafer edge, without burrs or cracks. Any such defects at the edge of the wafer will result in wafer breakage either during the subsequent processing steps or after the wafer has been integrated into the module. Though it is not possible to inspect 100% of the wafer edge, it is possible to do a quick visual inspection of the edge. Any defects found can be reviewed with a profiler. Figure 8(a) shows the Zeta-200 optical profiler with an edge profiling fixture. This fixture is used to orient the wafers at an angle to enable inspection of the top surface as well as the side wall of the wafer. Figures 8(b) and 8(c) show a wafer with an edge crack and a wafer with good edge quality respectively.
